Bulletin #: SB049
 Author: Richard Waters
 Rev: A
 Date: 10/22/2002
 Affected Models: Chief 2002
 Engine Serial #:

Service Bulletin

Flywheel Oil Passage-way check

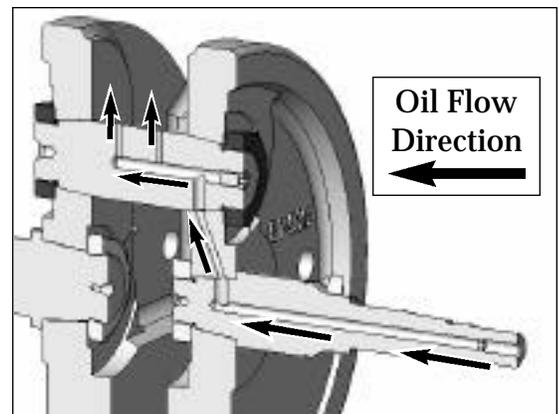
The objective of these instructions is to establish whether oil is travelling freely from the oil passage-ways in the cam cover assembly, through the passage-ways in pinion shaft and fly wheel to the crank pin bearings.

The most likely cause of a blockage is the misalignment of oil passage-ways between the pinion shaft and fly wheel or the fly wheel and crank pin.

Blocked or misaligned oil passage-ways will result in oil not reaching the crank pin bearings causing component failure.

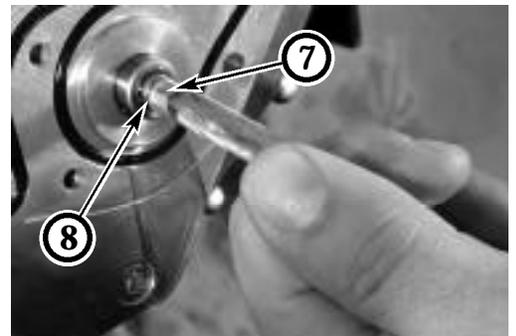
- 7 Using a small oil can, pump oil at least 5 times into the oil passage-way in the center of the pinion shaft.
NOTE: Hold the nozzle of the oil can firmly over the hole to create a good seal.
- 8 Oil should pump freely into the pinion shaft. Oil leaking back around the oil can's nozzle will indicate a blocked oil passage-way.

A blocked/misaligned oil passage-way may require an engine swap. Contact your Indian Field Warranty Representative (FWR) immediately for further action.
